# Cap Juluca, Anguilla, B.W.I.

coastal engineering

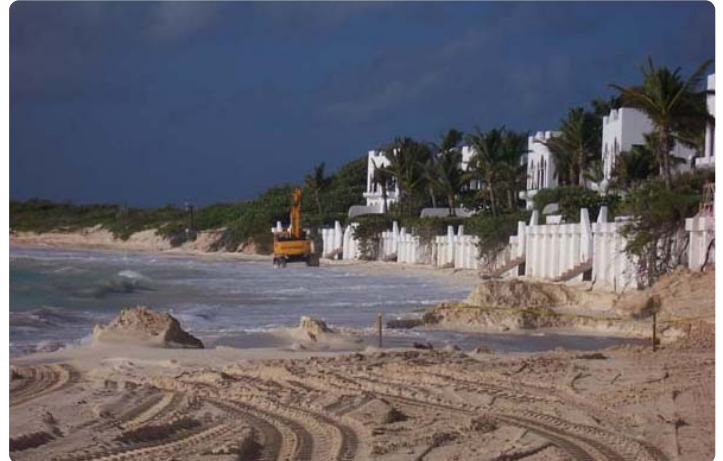
Beach Fill Placement

Coastal Systems designed a 25,000 cubic yard beach renourishment project that was constructed in approximately two (2) months prior to the peak resort tourist season in January. The renourishment project was also coordinated through the Department of Physical Planning within the Government of Anguilla. Coastal Systems also performed a study to evaluate the coastal processes at the site and to identify beach management maintenance and coastal structure alternatives. During the beach nourishment construction, Coastal Systems provided on-site construction survey stake-out and beach fill contract payment surveys. Beach construction was monitored daily with reporting and volume calculations. Coastal Systems also worked closely with the construction management team to evaluate alternate sources of sand to expedite the fill production to meet the schedule.

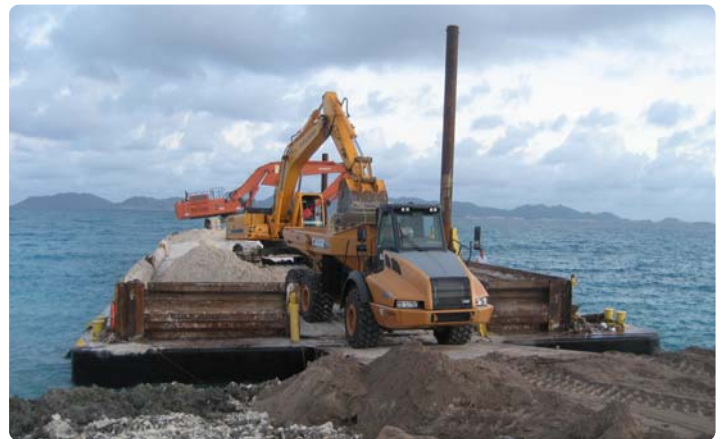
Earthworks in Progress for Beach Nourishment

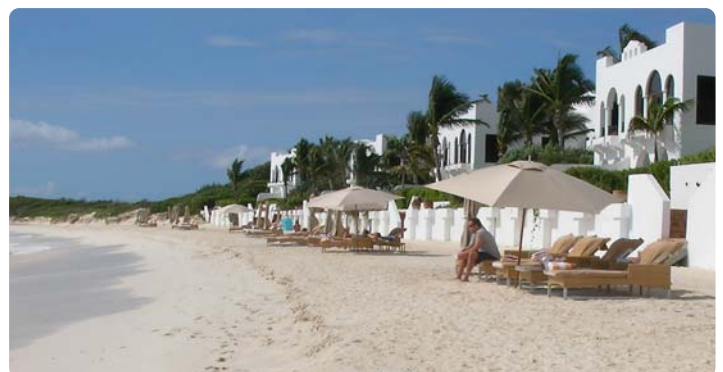
Completed Beach Renourishment
